OFFICE OF THE GRANT COUNTY SURVEYOR, MARION, INDIANA

A-19

Date ~~Recovered~~: 6 SEPTEMBER 2001Corner Description: NW COR - NE FR  $\frac{1}{4}$  2-22-8Corner Recovered by: A. GUERIN & D. WIMMER

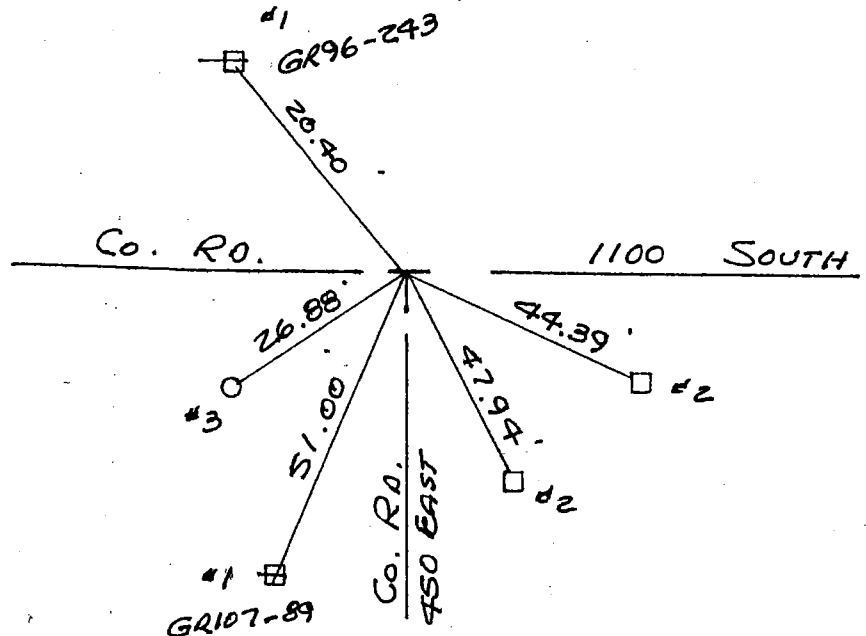
SITE MAP

Material Found: NO STONE OR METAL FOUND.References: 1. NAIL SET IN UTILITY POLE2. CONCRETE POST3. IRON POST4. \_\_\_\_\_5. \_\_\_\_\_6. \_\_\_\_\_Condition of Corner: \_\_\_\_\_

HOLE DUG AT POINT OF FENCE SPLITS, NO STONE FOUND. #6 REBAR SET WITH CAP BY LINE INTERSECTION OF EXISTING FENCES.
