Z-17

Corner Recovered by: A. GUERIN - D. WIMMER

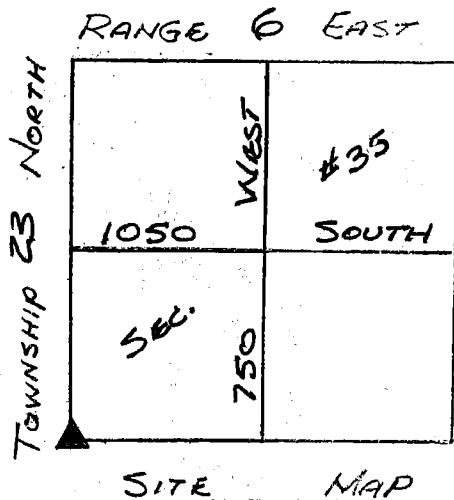
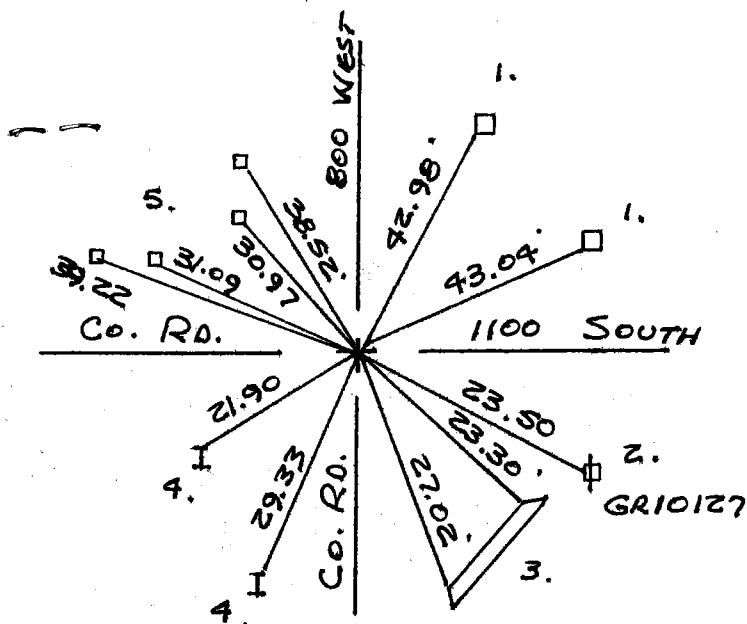
Material Found: STONE 1.5' COVER

1. CONCRETE POST
2. NAIL SET IN UTILITY POLE
3. CONCRETE HEADWALL
4. GUARDRAIL POST
5. NAIL SET IN WOOD post
6. \_\_\_\_\_

Condition of Corner: EXCELLENT

IRON PIPE FOUND OVER STONE. REPLACED WITH #6 REBAR WITH PLASTIC CAP. SMALL PK NAILS SET AT 5.0' FEET NW, SW AND EAST OF STONE.
