OFFICE OF THE GRANT COUNTY SURVEYOR, MARION, INDIANA

Date ~~Recovered~~: 24 APRIL 1992

Corner Description: NW COR - NW 1/4 36-23-6

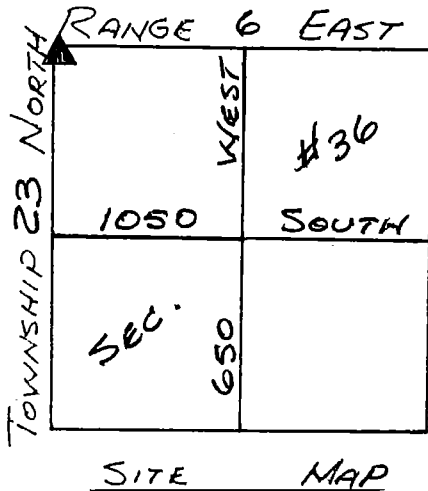
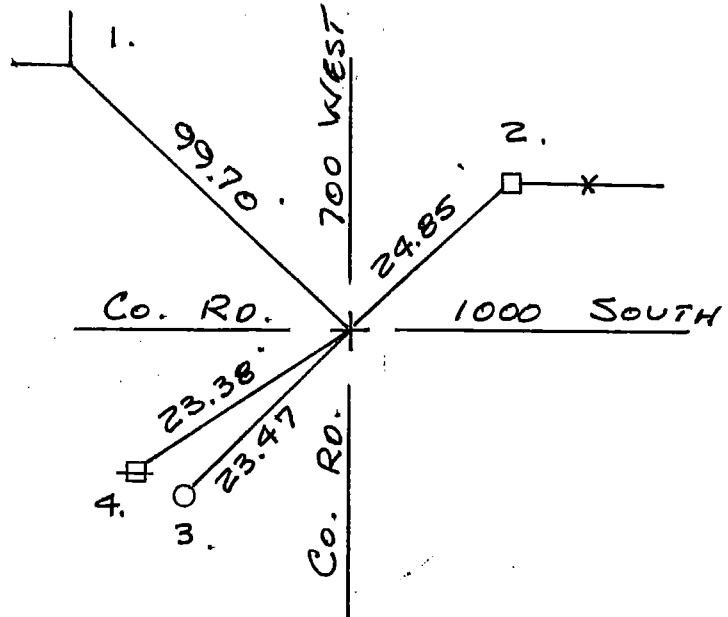
Material Found: NO STONE FOUND.

- References:
- CORNER OF BRICK PORCH
  - BOTTLE CAP SET IN WOOD POST
  - CONCRETE POST
  - BOTTLE CAP SET IN PWR. POLE GR9075
  - \_\_\_\_\_
  - \_\_\_\_\_

#6 REBAR SET. (SEE REVERSE SIDE)

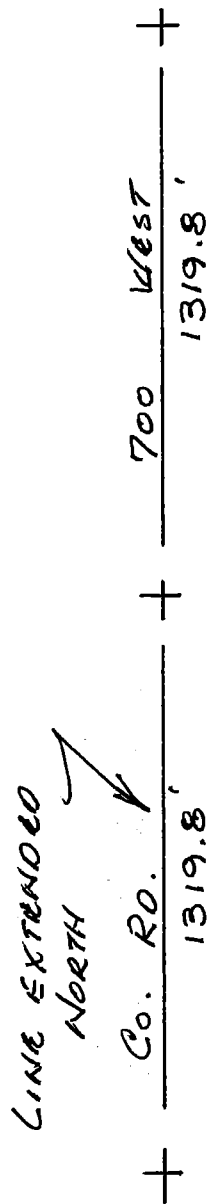
NW COR - NW  $\frac{1}{4}$   
#6 REBAR SET

SW COR - NW  $\frac{1}{4}$  - NW  $\frac{1}{4}$   
STONE FOUND

SW COR - NW  $\frac{1}{4}$   
IRON PIPE FOUND
