## CORNERSTONE RECORD BOOK

OFFICE OF THE GRANT COUNTY SURVEYOR, MARION, INDIANADate Recovered: 18 NOV. 1993Corner Description: NW Cor - SW 1/4 13-23-7Corner Recovered by: A. GUERIN & D. WIMMER

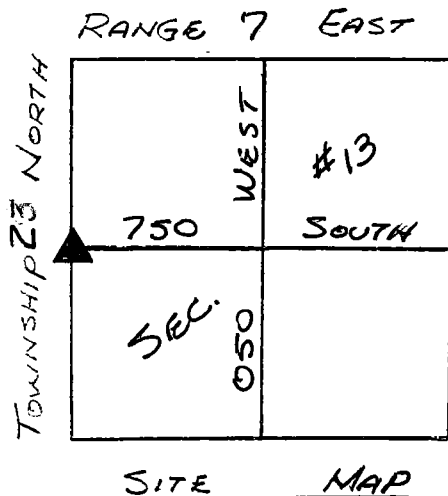
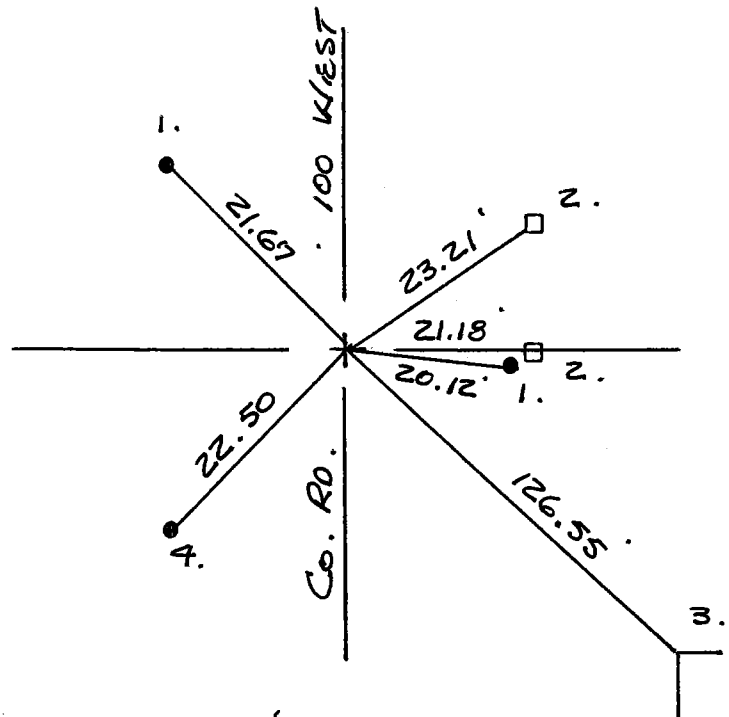
Material Found: GRANITE STONE 0.4' COVER

- References:
1. IRON PIPE FOUND
  2. NAIL SET IN WOOD POST
  3. PORCH FOUNDATION
  4. #6 REBAR SET
  5. \_\_\_\_\_
  6. \_\_\_\_\_

Condition of Corner: EXCELLENT

IRON PIPE FOUND OVER STONE, REPLACED WITH #6 REBAR WITH PLASTIC CAP.

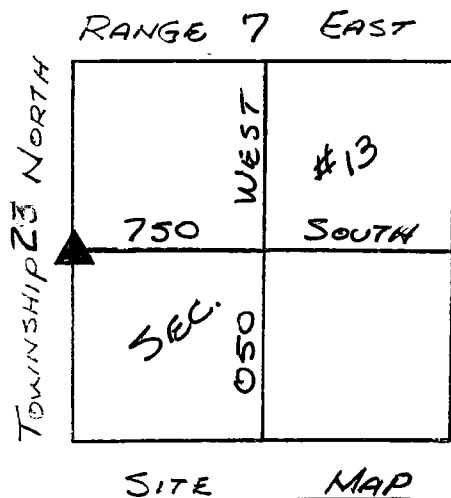
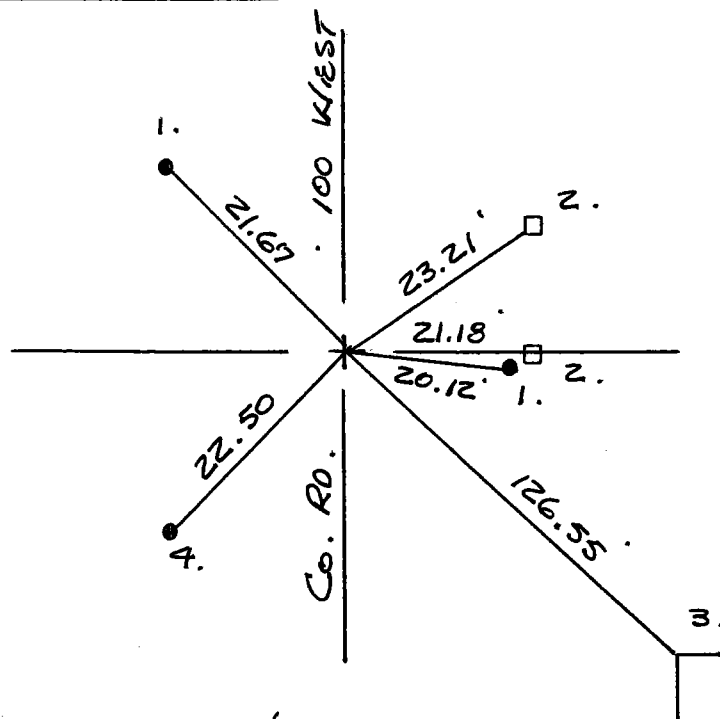
Material Found: GRANITE STONE 0.4' COVER

- References:
1. IRON PIPE FOUND
  2. NAIL SET IN WOOD POST
  3. PORCH FOUNDATION
  4. #6 REBAR SET
  5. \_\_\_\_\_
  6. \_\_\_\_\_

Condition of Corner: EXCELLENT

IRON PIPE FOUND OVER STONE, REPLACED WITH #6 REBAR WITH PLASTIC CAP.
