OFFICE OF THE GRANT COUNTY SURVEYOR, MARION, INDIANA N-7

RESTORED

Date ~~Restored~~: 25 JANUARY 1996Corner Description: SW COR-SE<sup>1</sup>/<sub>4</sub> 17-23-7Corner Recovered by: A. GUERIN & D. WHITMER

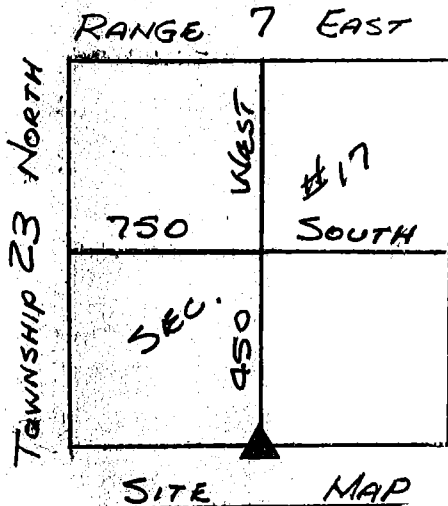
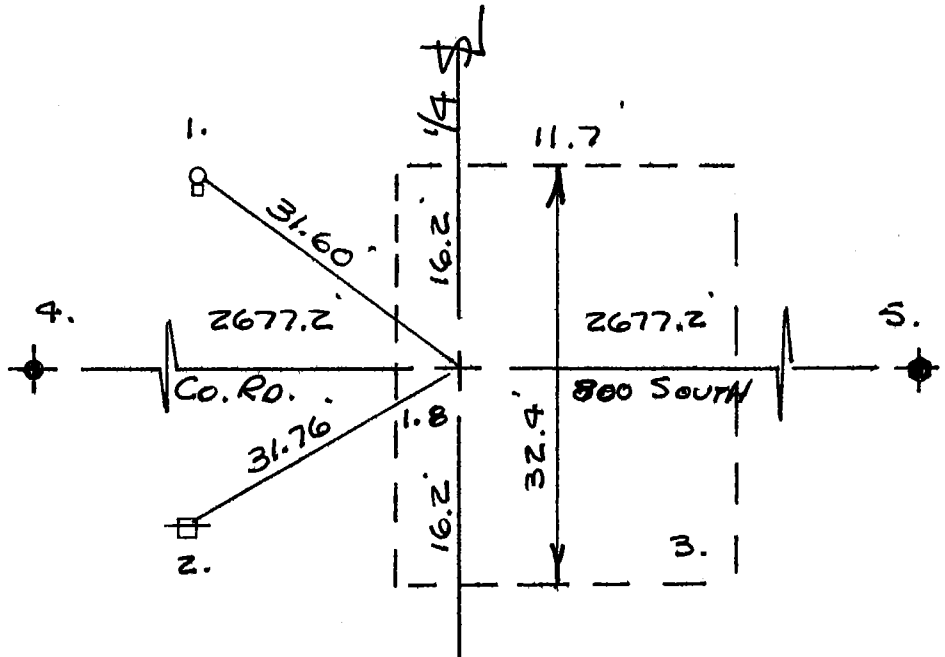
Material Found: CORNER TAKEN OUT BY NEW CULVERT.

- References:
1. NAIL SET IN WOOD POST WITH PHONE BOX
  2. NAIL SET IN UTILITY POLE
  3. NEW CONCRETE BOX CULVERT
  4. IRON PIPE FOUND @ SW COR-SW<sup>1</sup>/<sub>4</sub> 17-23-7
  5. STONE @ SE COR-SE<sup>1</sup>/<sub>4</sub> 17-23-7
  6. \_\_\_\_\_

QUARTER SECTION CORNER SET BY SPLITTING NAIL AND CONCRETE CULVERT. PK NAIL SET AT SURFACE.
